E6211.02-113-11-R0
ACOUSTICAL PERFORMANCE TEST REPORT
ASTM E90

TREX COMPANY, LLC

Series/Model: Trex[®] Seclusion[®]

Type: Sound Barrier Fence

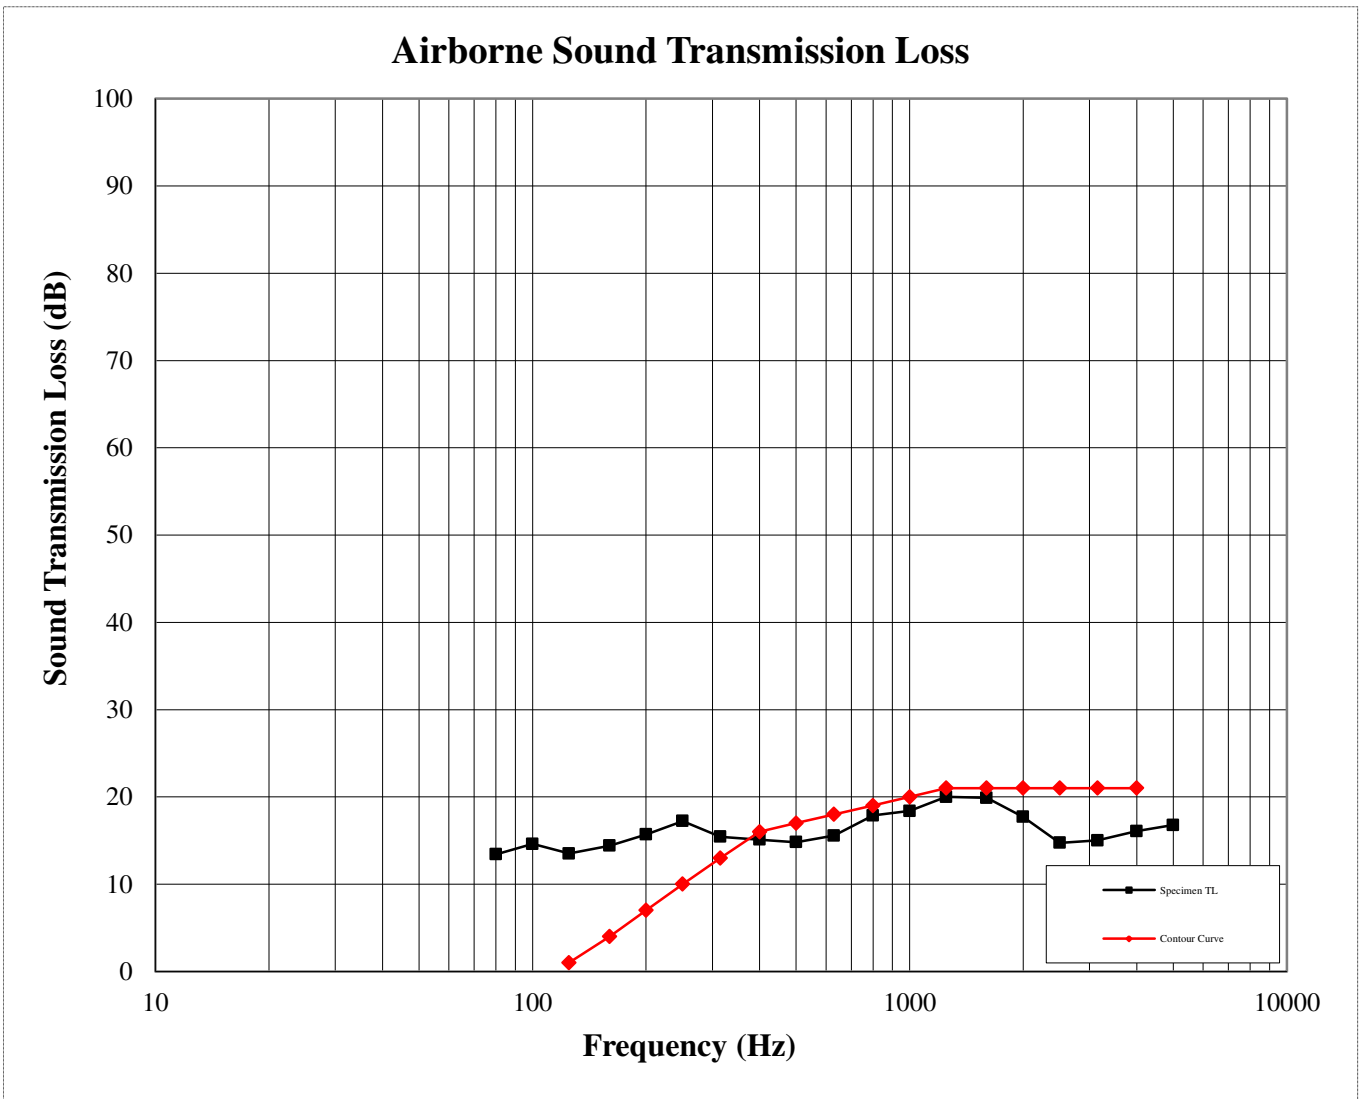
AIRBORNE SOUND TRANSMISSION LOSS
ASTM E 90

Test Date	03/24/15					
Data File No.	E6211.01					
Client	Trex Company, LLC					
Description	Series/Model: Trex® Seclusion®, sound barrier fence					
Specimen Area	5.95 m ²	Receive Temp.	22.5 °C		Source Temp.	20.9 °C
Technician	Kurt A. Golden	Receive Humidity	46%		Source Humidity	47%

STC Rating **17** *(Sound Transmission Class)*
Deficiencies **30** *(Sum of Deficiencies)*
OITC Rating **16** *(Outdoor-Indoor Transmission Class)*

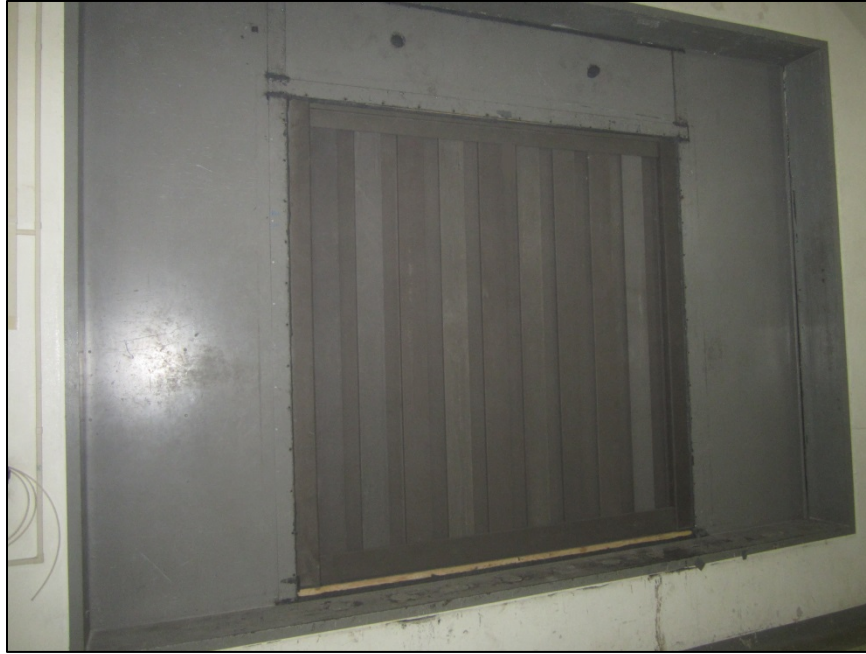
Receive Room View of Installed Specimen

A sound transmission loss test was initially performed on a filler wall. The 96" wide by 96" high specimen plug was removed from the filler wall assembly. The specimen was constructed in the laboratory per the manufacturer's instructions. Duct seal was used to seal the perimeter of the specimen to the test opening on both sides. The interior side of the specimen frame, when installed, was approximately 1/4" from being flush with the receive room side of the filler wall.

A composite material fence section measuring 96" by 96" was tested. The original client provided all test materials, and the test specimen did not arrive assembled. Eighteen vertical picket sections were installed between two end posts.

An aluminum bottom rail was mounted horizontally, and the rail utilized a fence picket on either side. Each picket was 5-3/4" wide by 1" thick with 1/4" thick walls. The end posts were a 4-7/8" hollow square with 1/2" thick walls. A top rail capped off the pickets and measured 5" tall by 4-1/8" wide with 1/2" thick walls.

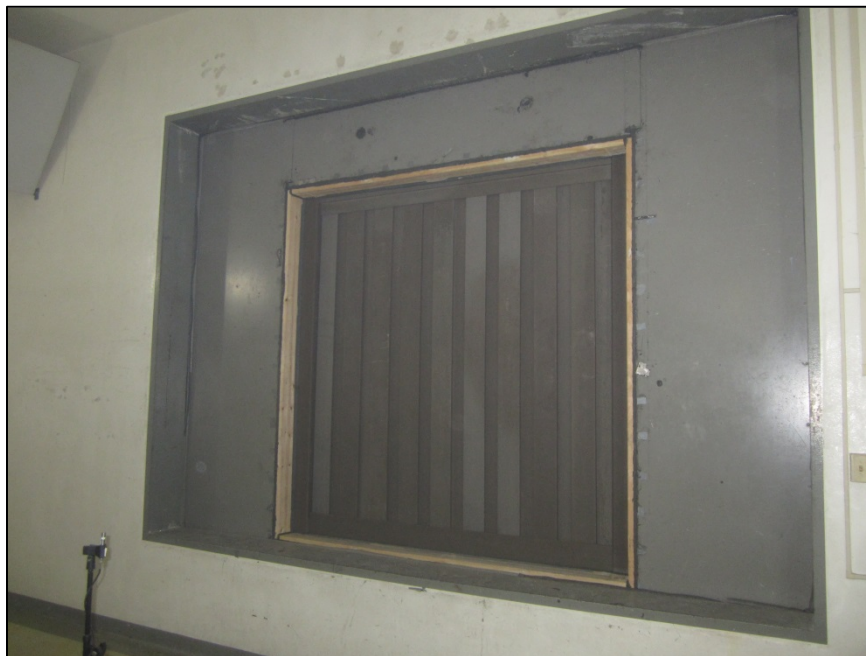
Source Room View of Installed Specimen
