**CREEP PERFORMANCE
TEST REPORT**

TREX COMPANY LLC

**Seclusions Composite Privacy Fence System
TYPE: Composite Fence System**

Report No.: 63565.01-116-20
Report Date: 07/06/06
Expiration Date: 06/30/10

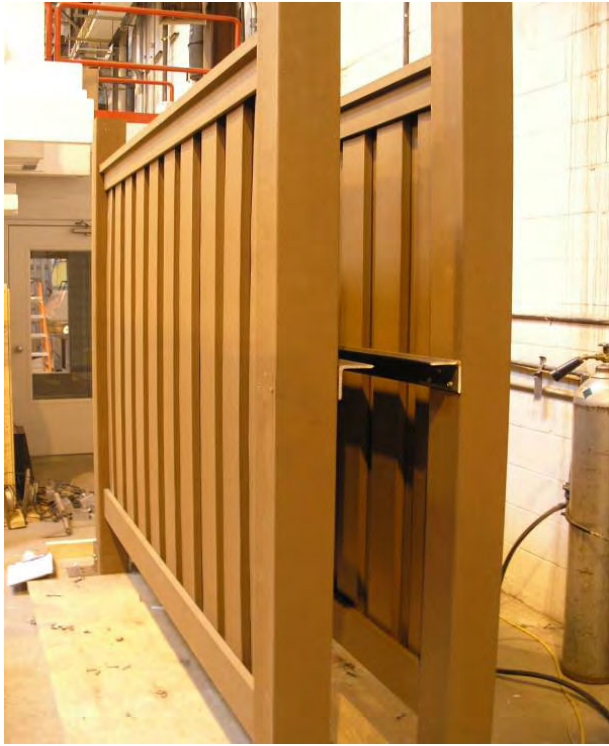
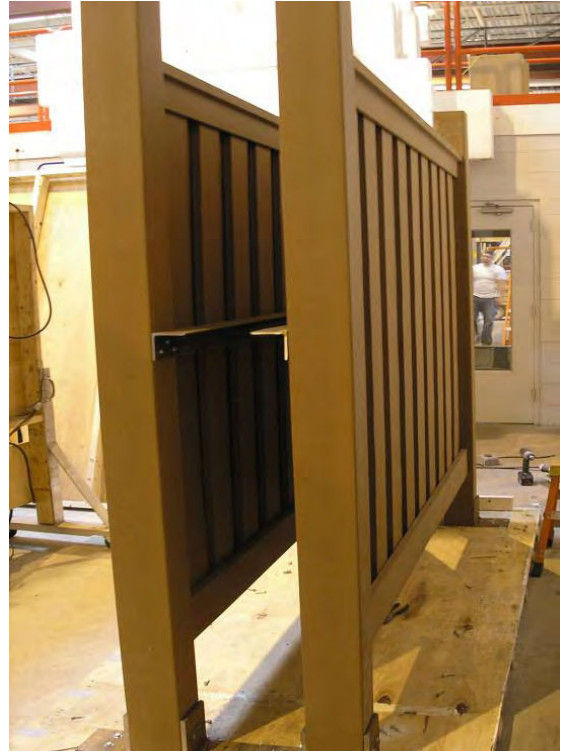
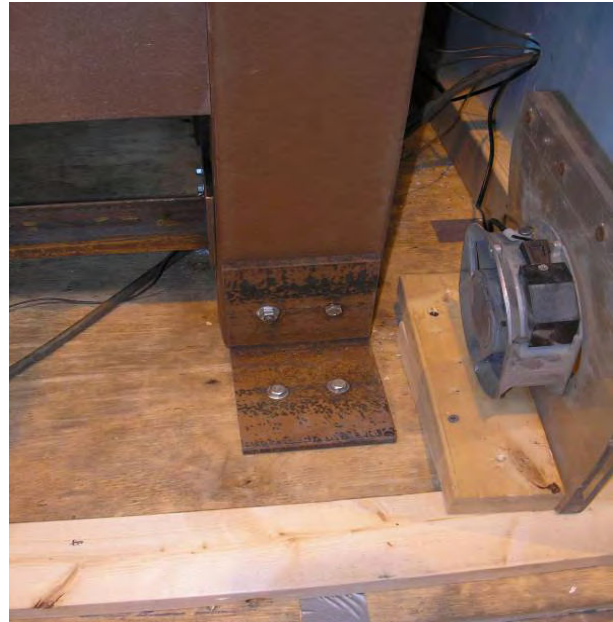
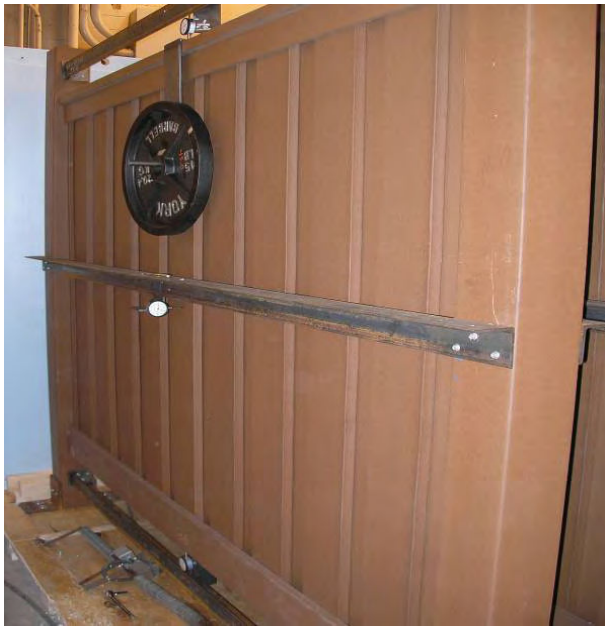
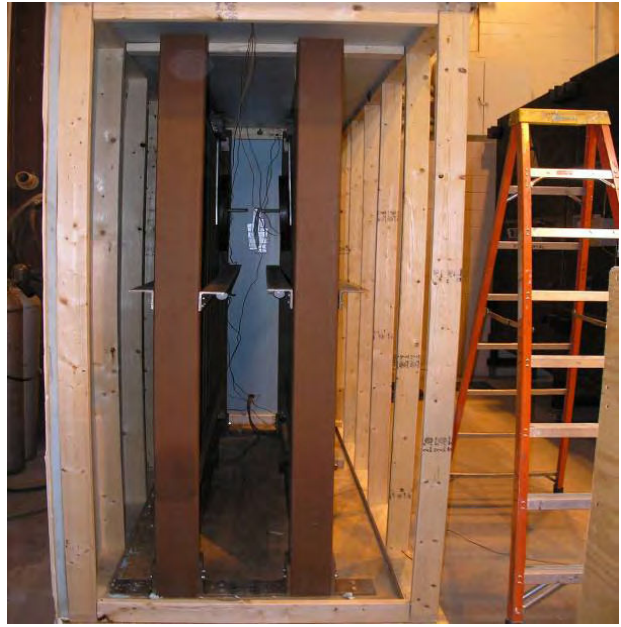
Test Setup Photographs

The two fence systems were constructed, as specified by the manufacturers instructions, and secured with two 1/2" thick steel angles per corner post with two bolts through each of the corner posts and two lag screws per angle into the insulated test chamber base. An insulated box was then constructed around the samples to encapsulate the two fence systems for high temperature conditioning. Viewing ports were installed into the insulated box for visual inspection and reading of the dial indicators. The fence systems were monitored and instrumented with four dial indicators per sample to measure the creep of the upper and lower rails and the lateral deflection of the fence panels. Each of the dial indicators were mounted to 1/4" thick steel angles which were secured to the corner posts. Circulation fans were utilized to ensure uniform temperatures throughout the insulated box. It should be noted that one fence system was nailed, by Trex Company LLC personnel, through the top rail to pin the fence panels to the top rail. A complete set of photographs have been provided in Appendix A illustrating the test setup and installation.

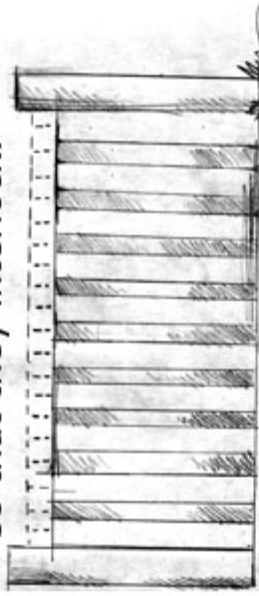
Interlocking Pickets

Alternate their orientation, so that they interlock.
